Fukushima-1: What happened, what's the present status, and what could be the impact?

Wim C. Turkenburg

Woudschoten Natuurkunde Conferentie

17 December 2011

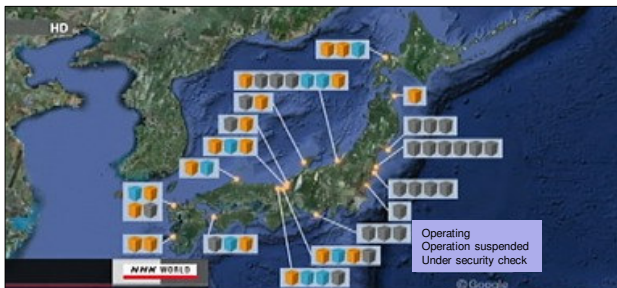
Over 80% of Japan's reactors offline

"If none of the reactors restart, Japan will have no active nuclear power plants within several months".

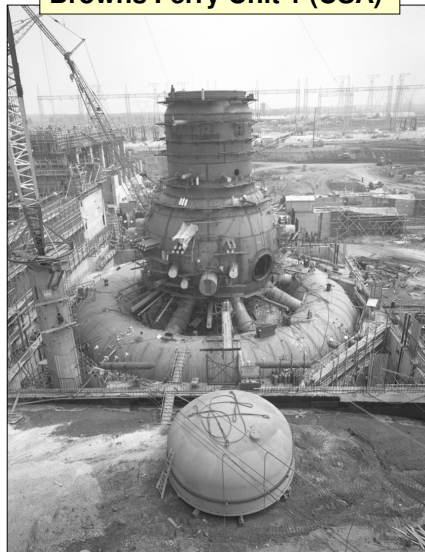
Browns Ferry Unit 1 (USA)

Browns Ferry Unit 1 drywell and wetwell under construction. (a BWR/4 using the Mark I containment)

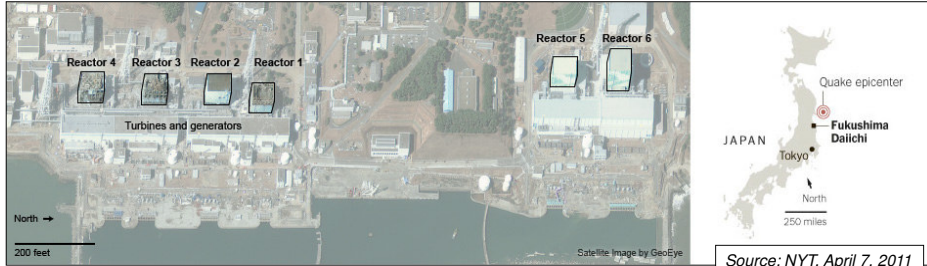
Earthquake and tsunami at nuclear power plant Fukushima-1

Earthquakes that struck northern Japan

- Friday, March 11, 2011
Magnitude: 9.0; Depth: 32 km
- Thursday April 7, 2011
Magnitude: 7.1; Depth: 66 km
- Monday April 11, 2011
Magnitude: 7.1; Depth: 10 km
- Friday, August 19, 2011
Magnitude: 6.8; Depth: 20 km

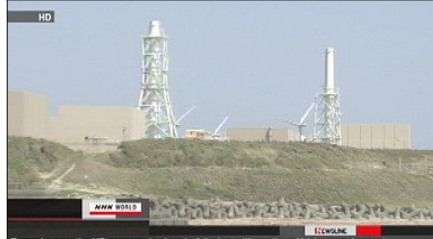
- In response to the accident at the Fukushima nuclear power plant, the government instructed the nation's power companies on March 30 to take urgent safety measures to prevent damage from tsunami.
- Hokuriku Electric Power Company started construction of a reinforced concrete seawall at the plant in Shika Town, Ishikawa Prefecture. The wall is 4 meters high, 700 meters long, and sits 11 meters above the sea level

- 45 of the 54 reactors around the country are planning to build seawalls.
- Construction is expected to be completed as early as spring 2012, or in the next 3 years at the latest.

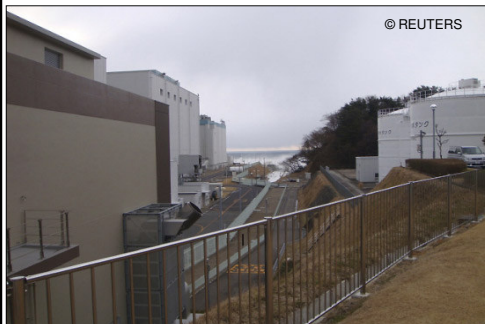
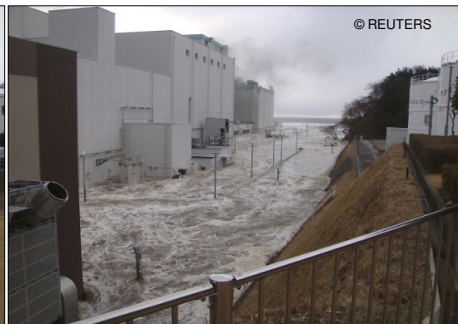
Fünfzehn-Meter-Welle traf Atomkraftwerk

Das Atomkraftwerk unmittelbar vor dem Tsunami

The earthquake generated a series of **seven tsunamis** that arrived at the site starting at 15.27 h, 41 minutes after the earthquake. The first wave was approximately 4 meters high, **the highest one approximately 14 m**. The tsunami inundated the area surrounding units 1-4 to a depth of about 4 meters above grade, causing extensive damage to site buildings and flooding of the turbine and reactor buildings. Intake structures at all six units were unavailable because of the damage. **The damage resulted in a loss of the ultimate heat sink for all units.**

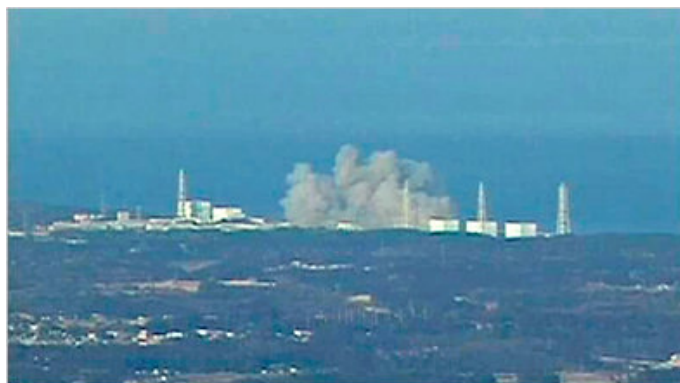
Explosion at reactor 1 of Fukushima-1

Source: Reuters

- March 12: Operators start injecting water into the reactor to cool it. Melt down of the core. The pressure-suppression pool stops working properly. **Hydrogen explosion** blows the roof and top walls off the reactor building. Reactor containment vessel seems not significantly damaged. Radioactive materials, including Iodine-131, are detected. Workers start flooding the reactor with seawater in a desperate effort to cool it.

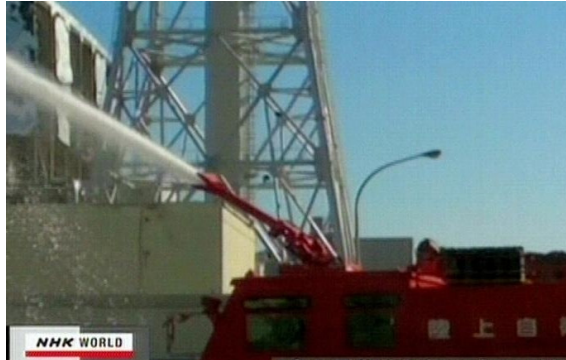
Trucks spraying water

19. und 20. März: Mit Wasserwerfern und Feuerwehrequipment werden die Reaktoren gekühlt. In einem 13-stündigen Einsatz hatte ein Feuerwehrfahrzeug Wasser aus dem Meer auf Block 3 gepumpt. Auf den erheblich beschädigten Block sind vermutlich mehr als 2000 Tonnen Wasser niedergegangen. Auch Block 4 wurde für zunächst etwa eine Stunde mit Wasser bespritzt. Ziel war es, den Wasserstand des Abklingbeckens mit abgebrannten Kernbrennstäben zu erhöhen. (Foto: AFP)

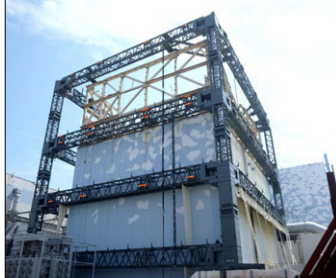
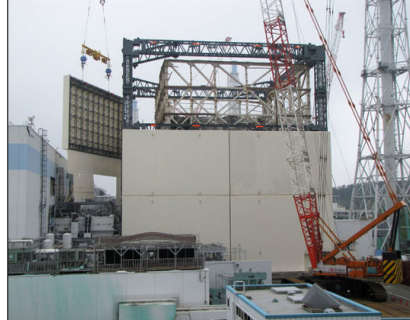
Current state of enclosure around unit 1

TEPCO has finished the steel framework for the heavy-duty plastic enclosure around reactor building 1. Completion of the structure to seal off the atmosphere from any possible unit 1 airborne releases, is scheduled for the end of October. Once unit 1 is "wrapped up", work will begin to provide units 3 & 4 with the same sort of enclosure.

September 19, The Japan Times posted a picture of the current state of construction on the enclosure around the unit 1 reactor building. TEPCO expects to be finished by mid-late October.

- A covering of thick polyester sheets has been attached to steel frames at the damaged No.1 reactor building at the Fukushima Daiichi nuclear plant. TEPCO plans to complete the covering and verify its effectiveness by the end of October.
- The work which began in late June is designed to decrease the release of radioactive materials into the air.
- The utility company will conduct a test-run to see how the system captures radioactive materials from the building with a filter.
- **TEPCO estimates the system should be able to remove about 90 percent of the radioactive materials.**
- TEPCO is considering installing covers on the No. 3 and 4 reactors which were also damaged.

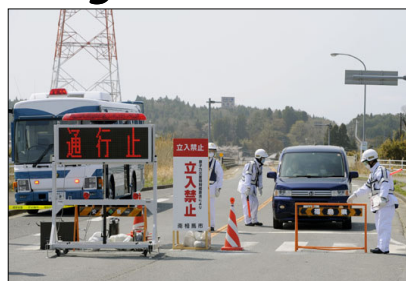
20-km evacuation area now declared a *no-go zone*

- The government declared the 20-km evacuation area around the radiation-spewing Fukushima No. 1 nuclear plant a no-go zone Thursday, urging residents to abide by the order for their own safety or possibly face fines or detention.
- Nearly 80,000 residents left when the area was evacuated March 12.

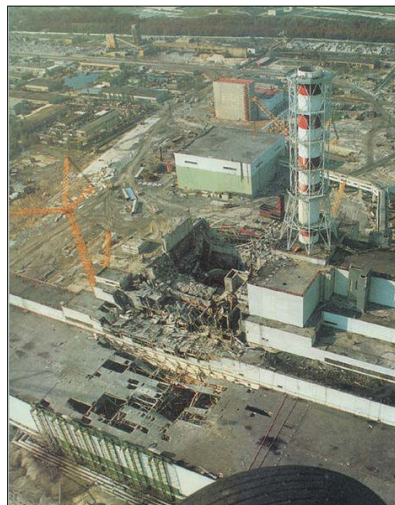
Chernobyl disaster 26 April 1986

- The Chernobyl disaster was a nuclear accident that occurred on 26 April 1986 at the Chernobyl Nuclear Power Plant in the Ukrainian SSR (now Ukraine).
- An **explosion** and **fire** released large quantities of radioactive contamination into the atmosphere, which spread over much of Western Russia and Europe.
- About **5.2 million terabecquerels radioactivity** have been emitted
- It is considered the worst nuclear power plant accident in history, and is one of only two classified as a **level 7 event on the International Nuclear Event Scale** – INES (the other one being the Fukushima-I accident).
